**ANNUAL REPORT
FOR THE
ROCKY FLATS ENVIRONMENTAL TECHNOLOGY SITE
GROUNDWATER PLUME TREATMENT SYSTEMS
January through December 2003**

January 31, 2005

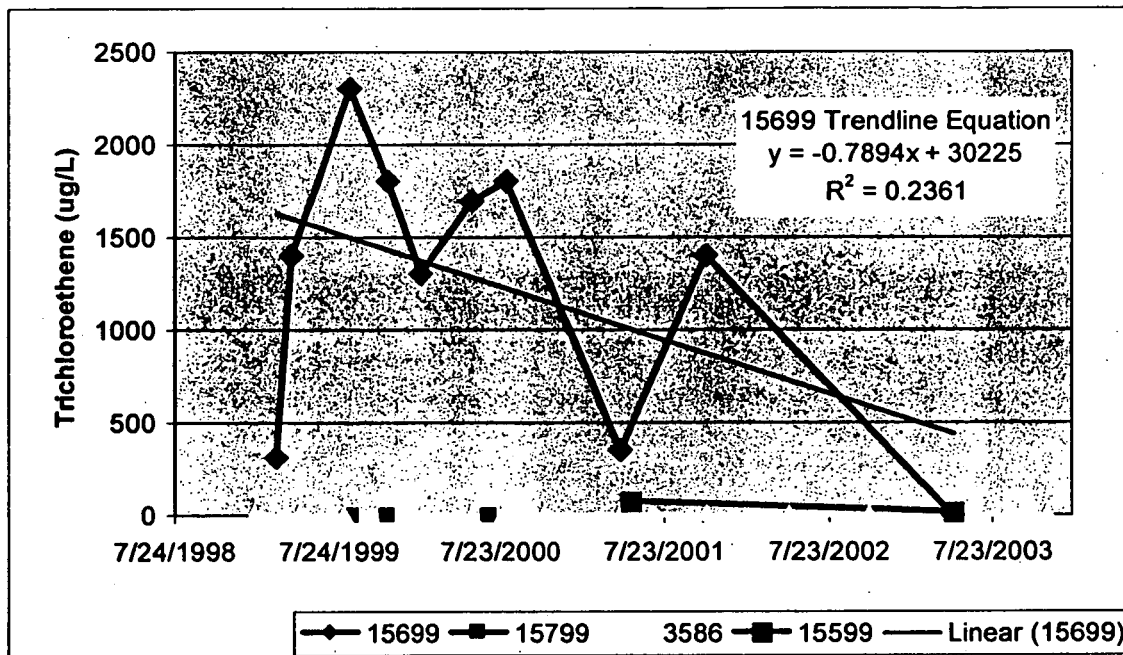
Figure 2. Mound Site Plume Downgradient Trichloroethene Concentrations

Concentrations in the downgradient wells indicate that the residual contamination levels are declining and that the collection system tends to mitigate downgradient plume concentrations. For example, concentrations at Well 15599, frequently dry in the past, have decreased since the previous sample collected in 2001. Well 3586 continued to have low concentrations as it has

had in the past. A decrease in trichloroethene concentrations was noted in Well 15699. Tetrachloroethene concentrations are more variable, and the downward trend is not as evident. This well is located within the preferential flow path for the Mound Site Plume and along the trend of the highest plume concentrations defined in the pre-remedial investigation (DOE 1997a).

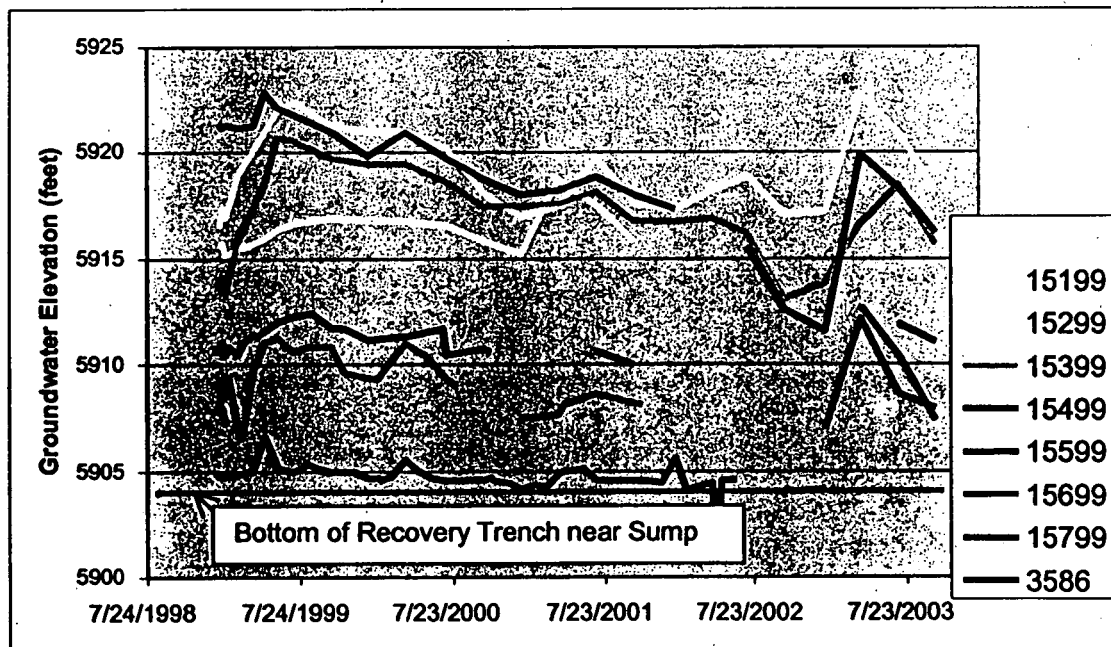
Figure 5. Mound Site Plume Water Elevations in Wells versus Time

and downgradient wells. Seasonal fluctuations were higher this year due to drought conditions in beginning of year followed by a heavy snowstorm in March. Groundwater elevations in Well 3586, near South Walnut Creek, remained within a few feet of the normal creek elevation of 5,903 feet in this area.

Water elevations are shown graphically in Figure 5. A simplified conceptual model of groundwater flow near the collection trench is shown on Figure 6. The hydraulic gradient induced by the trench can be seen in the difference in water elevations driving the water from the edges of the capture area, toward the center of the downgradient portion of the plume.

In January 2003, drought conditions greatly reduced the groundwater flow. As a result, the two outside downgradient wells, 15599 and 15799, were dry and the water level at 15699 was greatly reduced.

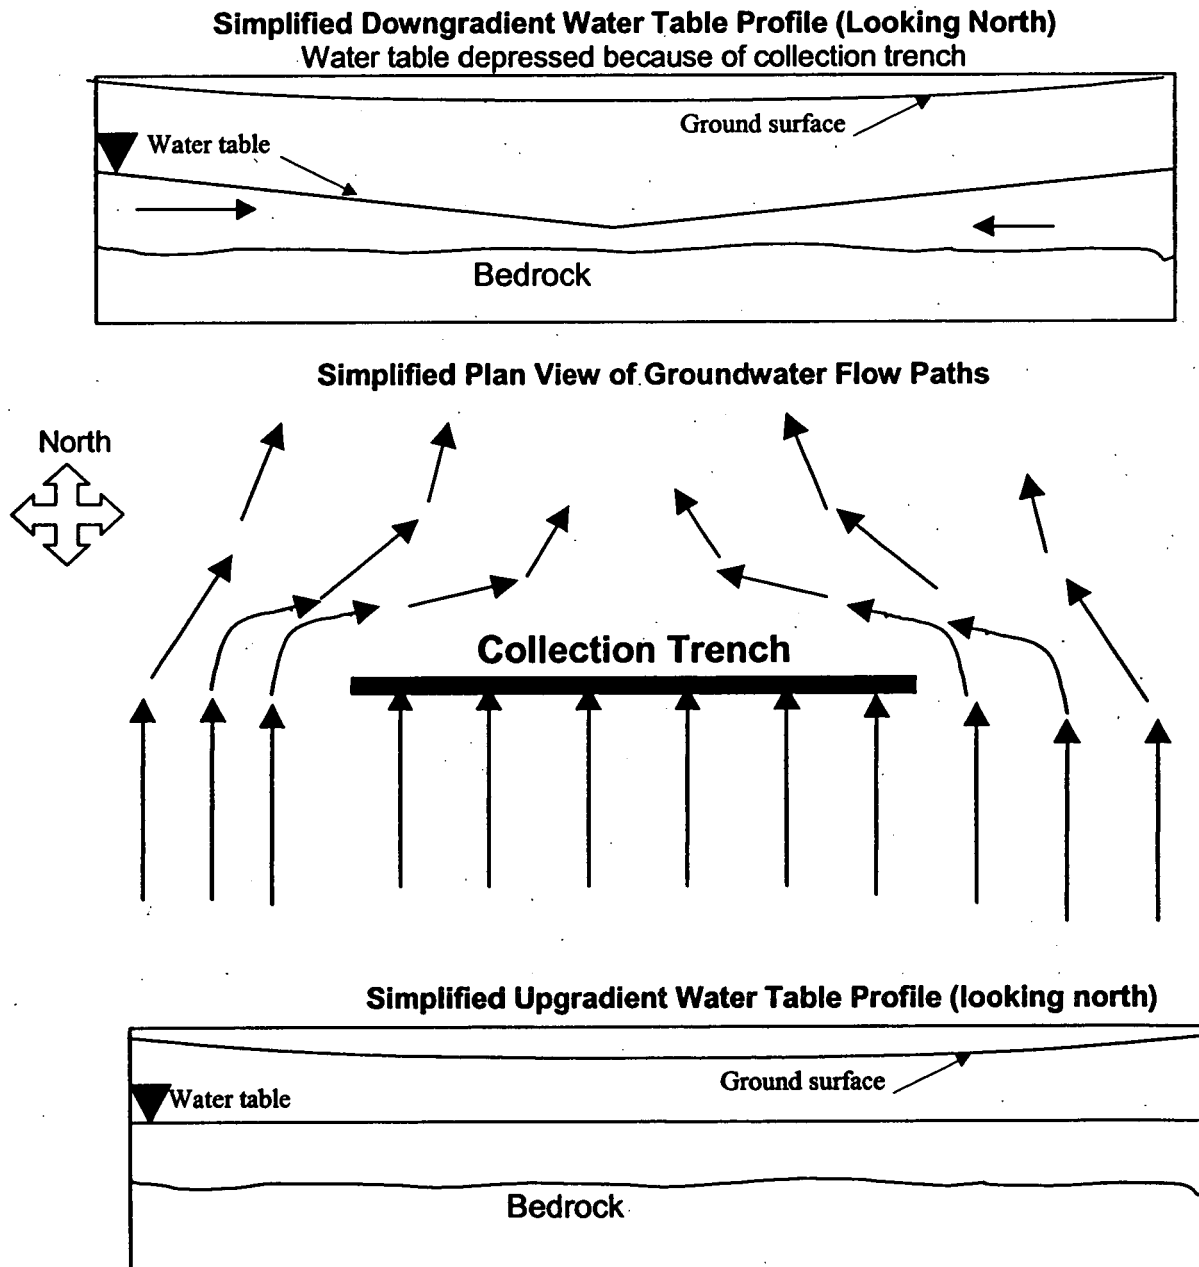
Figure 6. Conceptual Model of Groundwater Flow near the Mound Site Plume Collection Trench

snow pack melting above these areas and percolating downwards into the groundwater. The slope on the east side of the collection trench is flatter and may have allowed for more percolation into the soil. On the steeper sloped, west side of the collection trench, snowmelt is more likely to become run-off. By July, the downgradient groundwater profile returned to normal conditions that are illustrated on Figure 6. This is consistent with the intended design and indicates that the collection system is working effectively.

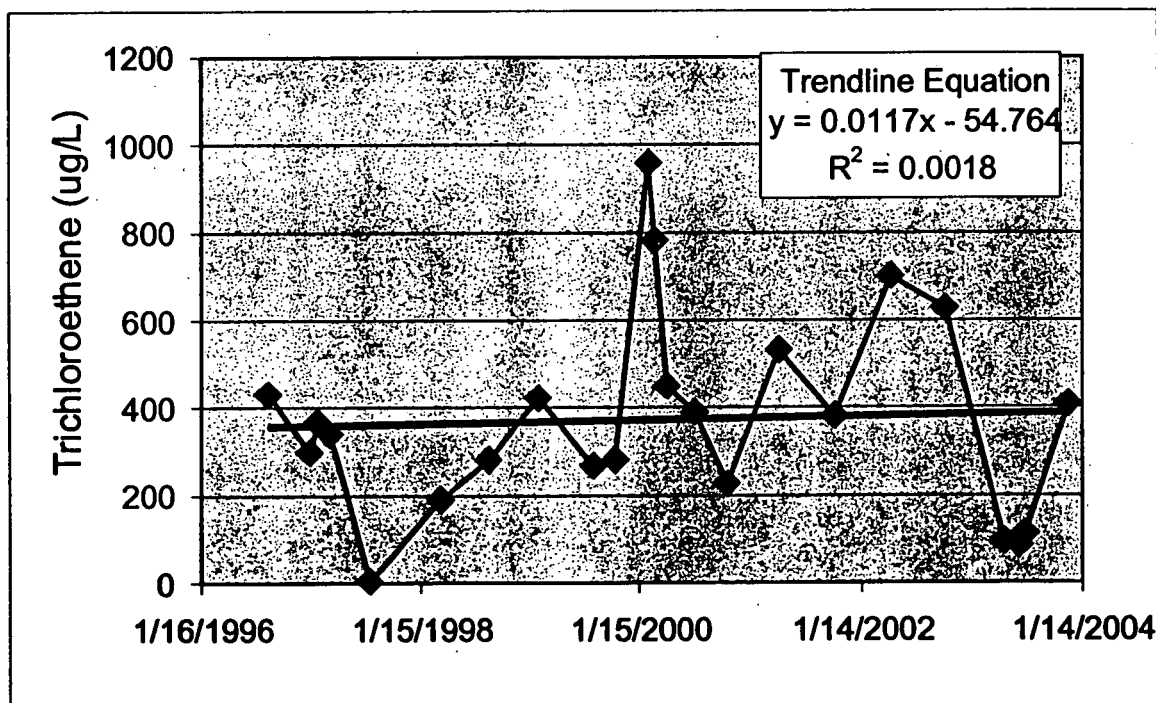
Figure 9. Historical Trichloroethene Trend in Well 23296

Groundwater trichloroethene concentrations at Well 23296 vary significantly (Figure 9). Figure 10 shows the sample results after the treatment system was installed. Contaminant concentrations in 2003 are lower than in the past. While there appears to be a downward trend, the data variation does not support a definite conclusion. Figures 11 and 12 show similar trends in tetrachloroethene concentrations. IMP monitoring is expected to continue at this location to determine if there is a downward trend in concentrations.

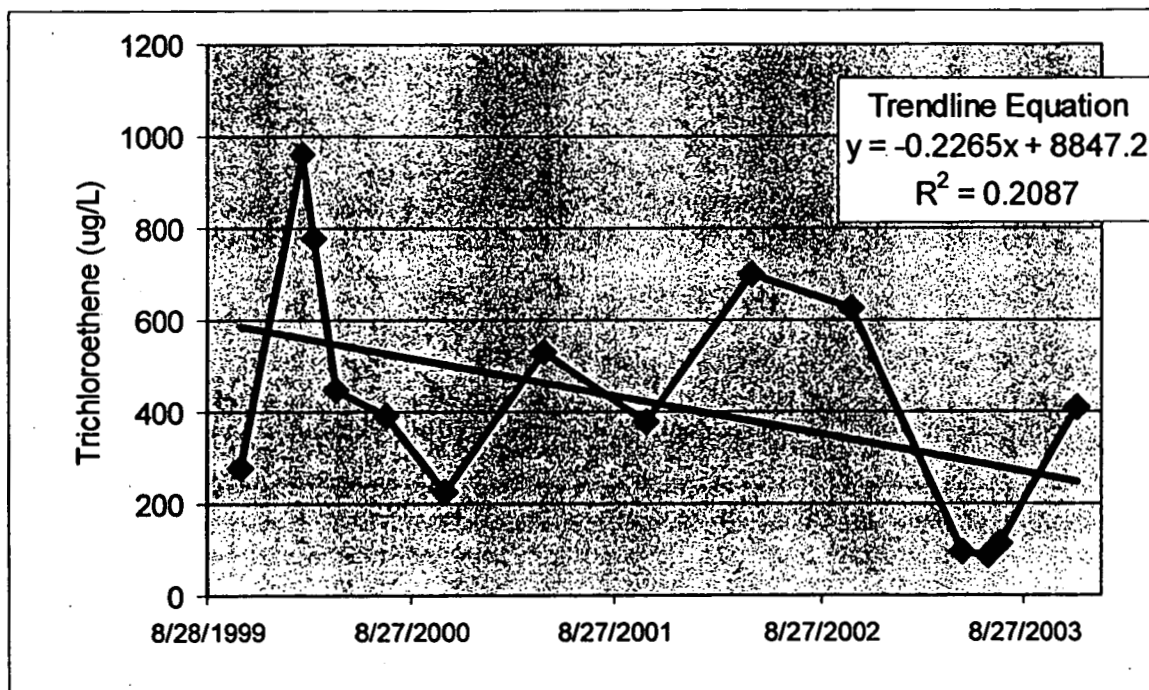
Figure 10. Trichloroethene Levels in Well 23296 During System Operation

The hydraulic gradients and saturated thickness in this area of Well 23296 could cause flushing of the contaminants. Although there appears to be decreasing trend in this well since the trench was installed, there are not sufficient data to verify this trend at this time. After evaluation of

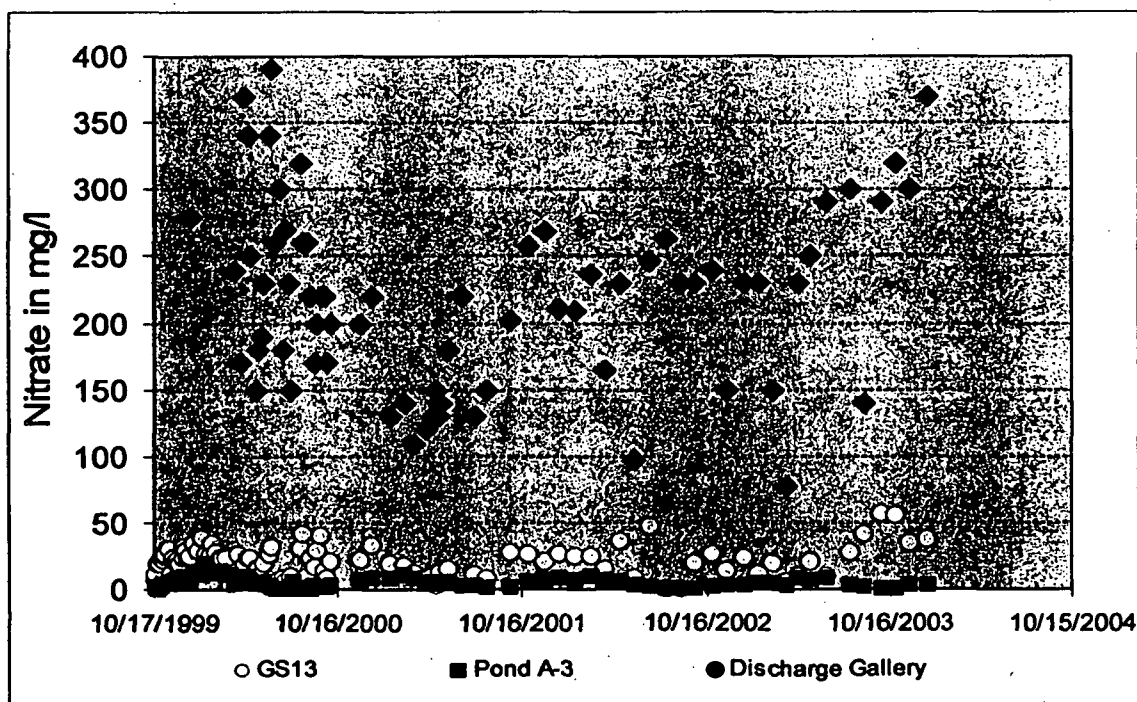
Figure 17. Nitrate Concentrations in Solar Ponds Surface Water Locations

GS-13 nitrate concentrations are significantly lower than the discharge gallery indicating that phytoremediation is occurring in this area from the established plants at the discharge gallery, and that the higher flow volume in the stream dilutes the discharge gallery effluent.

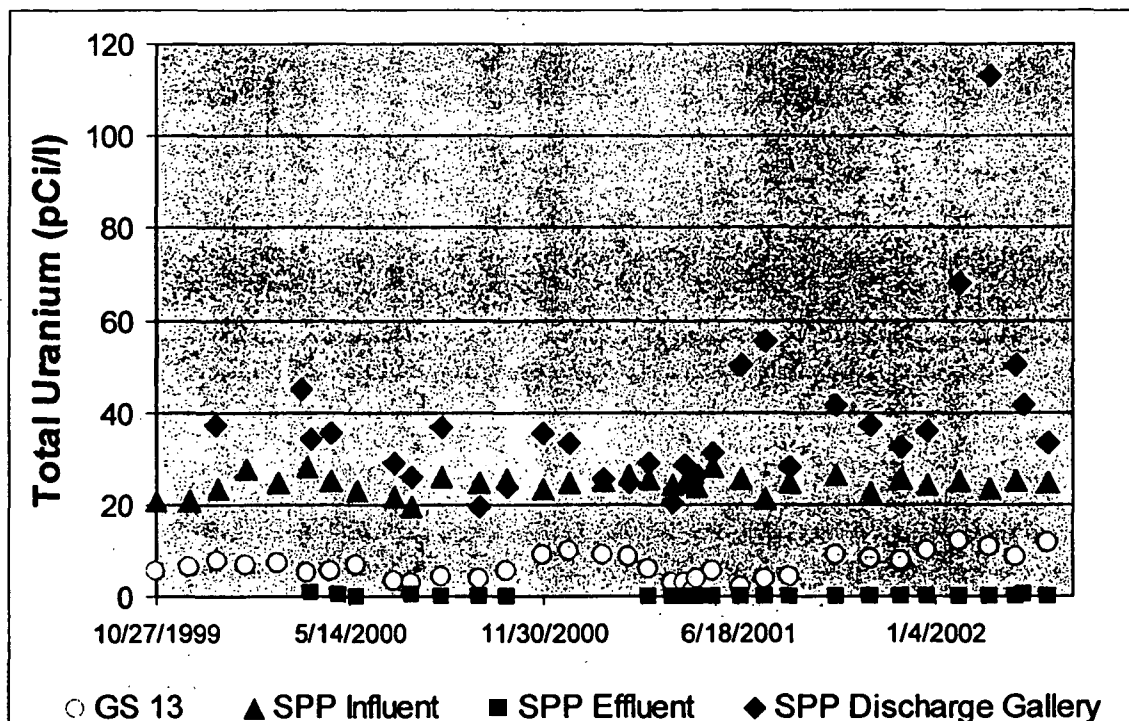
Figure 18. Uranium Activities in Solar Ponds Surface Water Locations

As indicated in Table 17 and Figure 18, uranium activities at GS13 were above 10 pCi/l for six months out of twelve, with the average below 10 pCi/l. However, sample results from the outfall of Pond A-4 (i.e., GS11, the RFCA point-of-compliance [POC] for uranium), remained below 10 pCi/l throughout the year ranging from 1.8 to 4.2 pCi/l for total uranium isotopes.

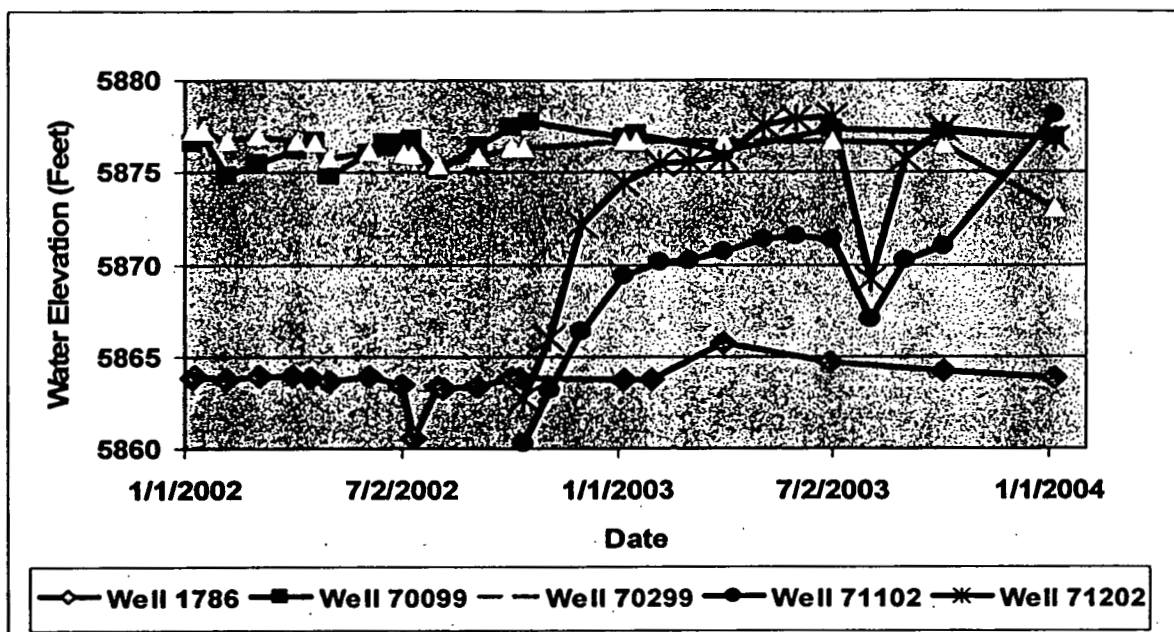
Figure 19. Solar Ponds Plume System 2003 Downgradient Well Water Elevations

Water levels in the downgradient wells of the system were monitored monthly. These data are provided in Table 18 and Figure 19. The groundwater elevations in the downgradient wells were relatively stable during 2003. Groundwater elevations in the two new piezometers (71102 and 71202) increased fifteen to eighteen feet since installation. This rise might be a result of the water levels equilibrating in the tight formations after well installation or to a leak in the collection trench panels. The pump maintains water levels below the elevation of the potential leak, so water levels should drop with time in these piezometers if these are associated with a leaking panel.

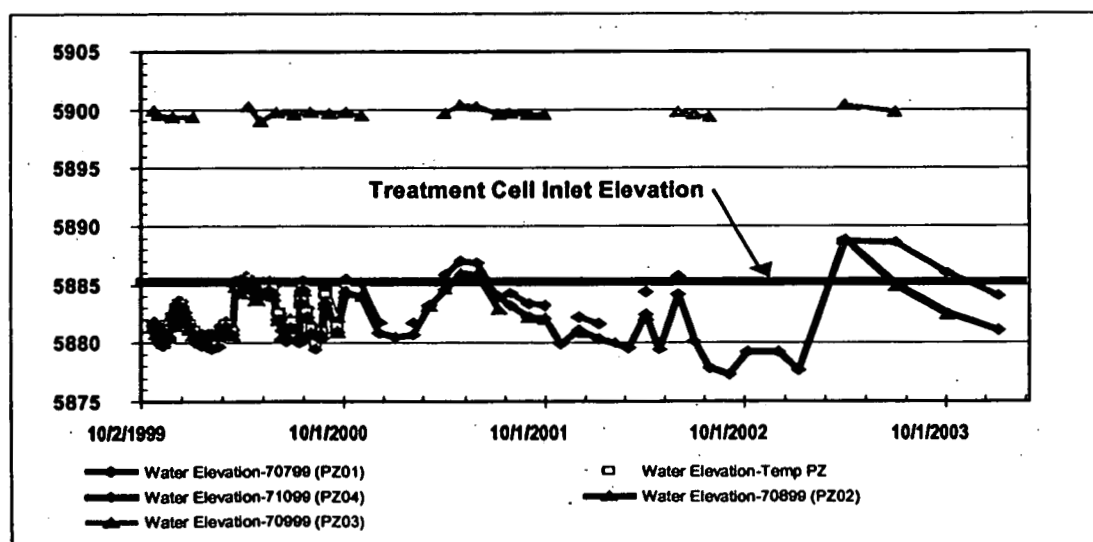
Figure 20. Solar Ponds Plume Collection Trench Piezometer Water Levels

Water levels within the collection trench are monitored at five piezometers at 70799, 70899, 70999, 71099 and Temp PZ. The inlet to the treatment cell is 5,885 feet above msl and the bottom of the collection trench is approximately 5,875 feet above msl. As shown in Figure 20, water levels in four of the piezometers fluctuate between 5,880 and 5,890 feet above msl. The fifth piezometer (70999), located at the higher, east end of the trench, has a minimum measurable water elevation of 5,900 feet. By design, water collected in this part of the trench drains to the west. This piezometer is generally dry when the water level of the other piezometers drops to 5,880 feet; however during the last half of 2003 it was dry even though water levels were fairly high at other locations.

The pump installed in 2002 is set to keep water in the sump below an elevation of 5880 feet, which should result in similar water elevations in the piezometers near the sump (all but 70999). The ability to maintain this level is limited by the capacity of the pump. The pump capacity was exceeded after the heavy March snowstorm and the water level rose in the trench. The water level continued to rise in the trench and remained elevated for some time, even with continued pump operation. Although the pump continued to operate and there was flow out of the treatment system, the elevated water levels in the trench indicated a partially plugged sump screen. The sump was redeveloped in 2004.

There is a significant difference in groundwater elevations between 70799 and the two nearby piezometers, 70899 and 71099, that has not been observed in the past. One potential explanation is that the pump in the collection trench causes fluctuation in water levels. Depending on when the measurements are made relative to the pump cycle, there may be a substantial amount of draw down when the pump is on.

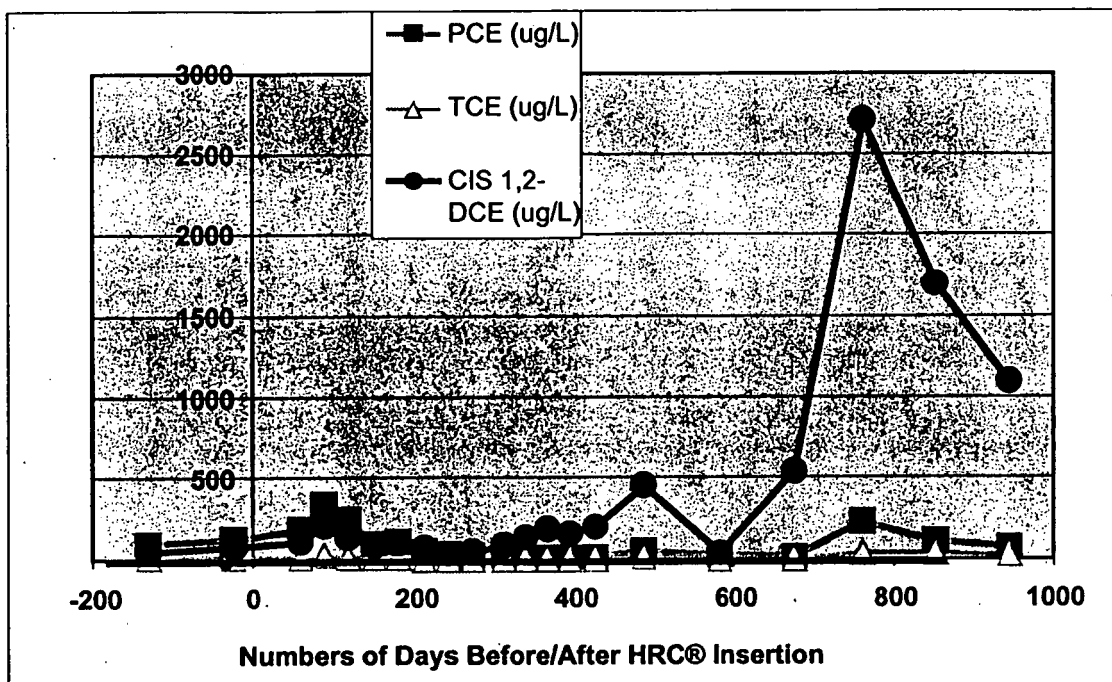
Figure 24. Tetrachloroethene and Degradation Products Concentration versus Time in Well 30900

Figures 24 and 27 also show cis 1,2-dichloroethene occur at higher concentrations in the source area than downgradient. Cis 1,2-dichloroethene is more resistant to anaerobic bacterial degradation than tetrachloroethene and its other byproducts. However, according to Regenesis, aerobic bacteria can more readily degrade it. In the downgradient well (31001), as conditions become more aerobic, the cis 1,2-dichloroethene appears to be readily degraded to vinyl chloride and then to ethene. Vinyl chloride is so readily degraded that it only appears occasionally in very low concentrations. Likewise, it is not anticipated that ethene would be found in detectable quantities since it degasses quickly. However it does appear in detectable quantities when the cis 1,2-dichloroethene is the highest in the source area. This could indicate that some cis 1,2- dichloroethene is completely degrading in the source area. No ethene has ever been detected in the downgradient well possibly due to the low concentrations of cis 1,2-dichloroethene.

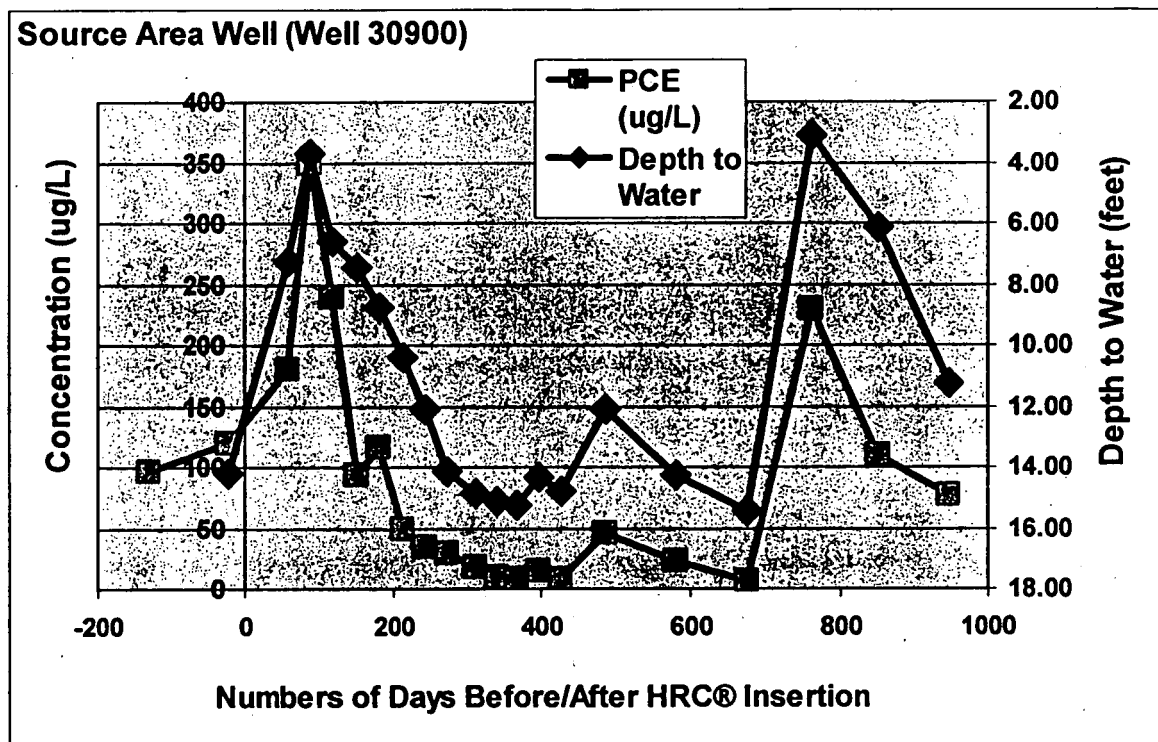
Figure 26. Tetrachloroethene Concentration and Depth to Water in Source Area Well 30900 versus Time

When the water table rises, the area of reduced conditions and anaerobic activity get larger, and the concentration of cis 1,2-dichloroethene increases as shown on Figures 25 and 26. Farther

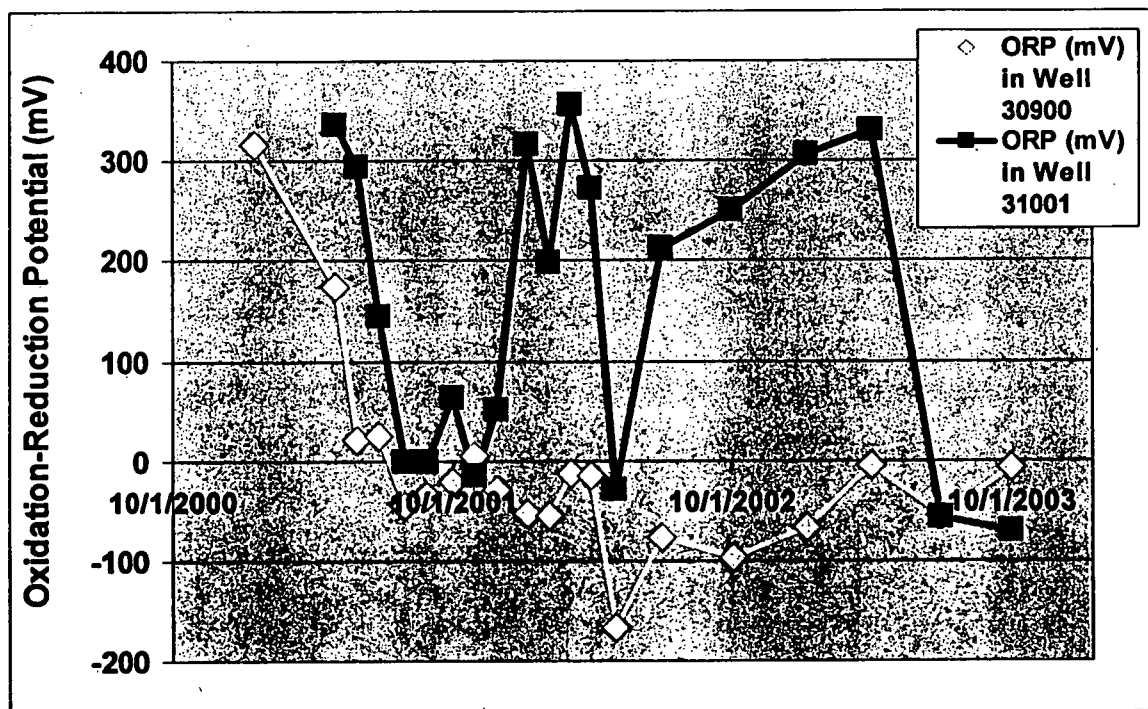
Figure 29. Oxidation Reduction Potential in PU&D Yard Wells versus Time

The area of anaerobic degradation appears to expand and contract with water table fluctuations. The area expands as the HRC[®] is released and contracts as it is consumed. Figure 29 shows how ORP changes with time in both the source area well (Well 30900) and in the downgradient well (Well 31001). The measurements were made using a silver/silver chloride electrode with a three-normal potassium chloride filling solution. Reduced conditions in the source area well increased as the anaerobic bacterial community developed. Since it is at the center of the community, it has remained in a reduced state while the downgradient well has responded to the expansion and contraction of the biological community

Downgradient, the area of reduced conditions increased but then contracted when the HRC[®] was consumed and the area of anaerobic degradation shrank. When the water table rose, and more HRC[®] became available, the area of reduced conditions again expanded. Since startup, this cycle appears to be occurring yearly. Figure 29 also shows seasonal variations in the downgradient well. When more HRC[®] was released in the spring, the area of anaerobic bacteria expanded to include this well and the oxidation-reduction potential dropped. This cycle appears to affect cis 1,2-dichloroethene the most.

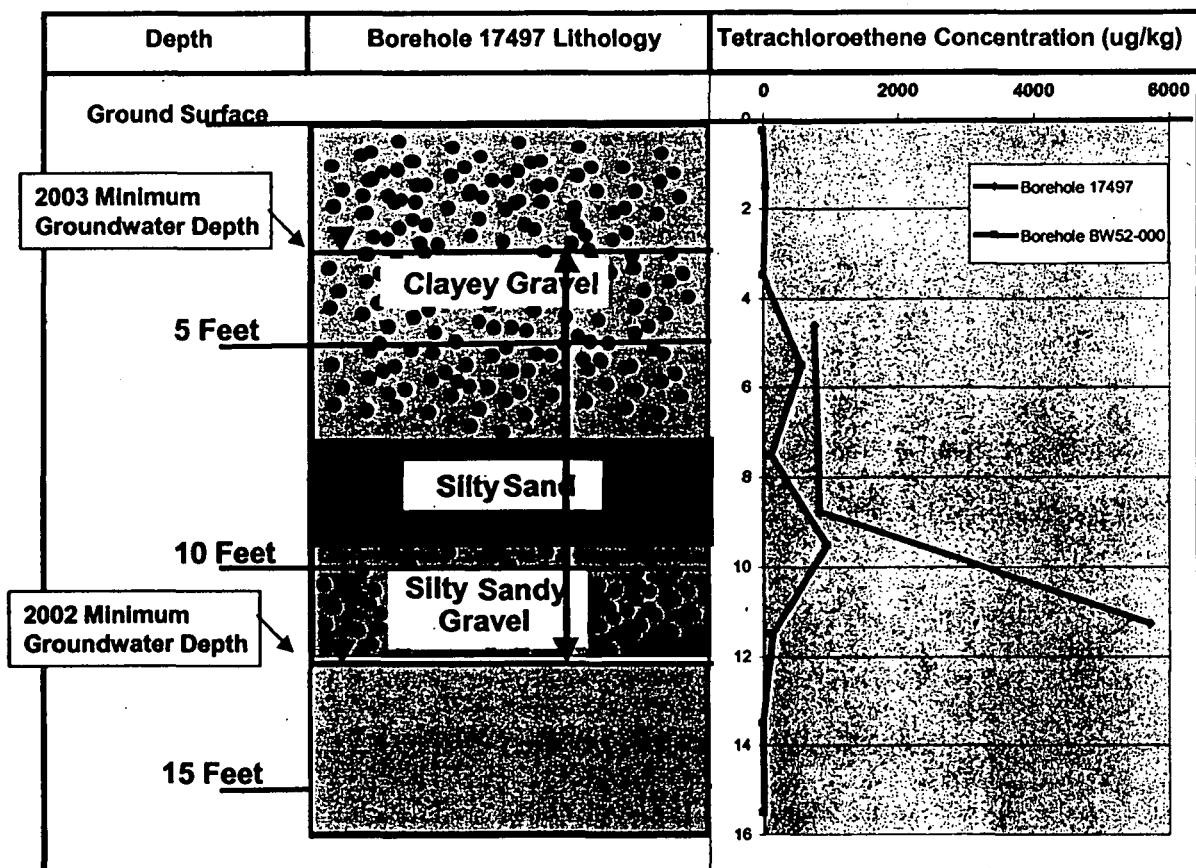
Figure 30. Lithology and Soil Concentrations of Tetrachloroethene (ug/kg) Versus Depth (feet from surface) in the Source Area

Figure 30 shows the differences in tetrachloroethene concentration with depth between the original sample and the sample after treatment. Prior to HRC® insertion, the highest concentration of tetrachloroethene was 5,700 micrograms per kilogram (ug/kg) occurring below the water table at a depth of 11.25 feet. The more recent sample from the corresponding borehole interval had a tetrachloroethene concentration of 140 ug/kg or a 97.5 percent reduction in concentration. As can be seen in Figure 30, there appears to have been a reduction in tetrachloroethene both above and below the water table, although there are no pre-existing data from beneath the water table.

Also shown on Figure 30 is the minimum groundwater depths for 2002 and 2003. This illustrates how groundwater levels rise and fall through contaminated vadose zone soils, the likely source
